Alameda Square

By Paul Mendoza

Alameda Square Building 3

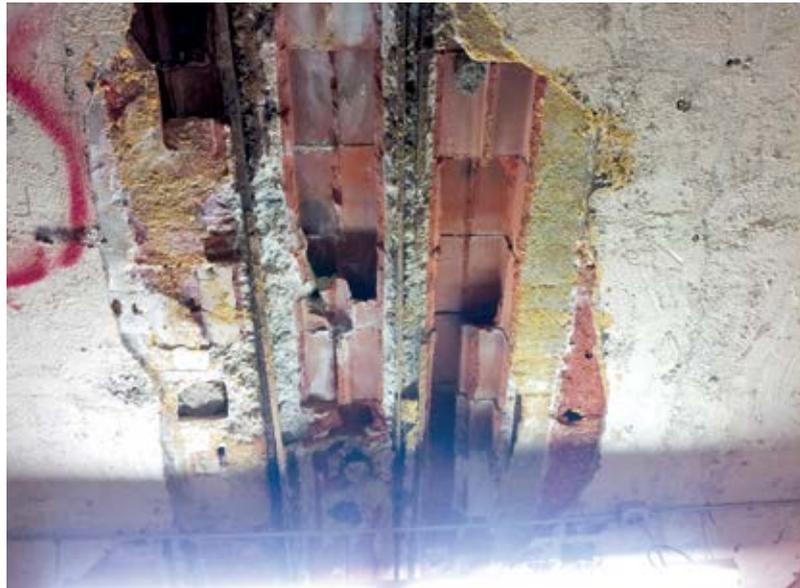
Fig. 1: An opened area showing the tile insulation and exposed existing reinforcing bar at the joists

Alameda Square Building 3, constructed entirely with reinforced concrete, at one point in its history was used as a deep-freeze facility by a food packaging company which had insulated portions of the concrete slabs and beams with cork and clay tiles. The years of exposure to freezing-and-thawing conditions caused spalling on the interior beams, concrete joists, and slabs; spalling was also evident on the exterior architectural concrete face of the building (refer to Fig. 1). The building was later repurposed as a garment manufacturing facility and still functions as such today.

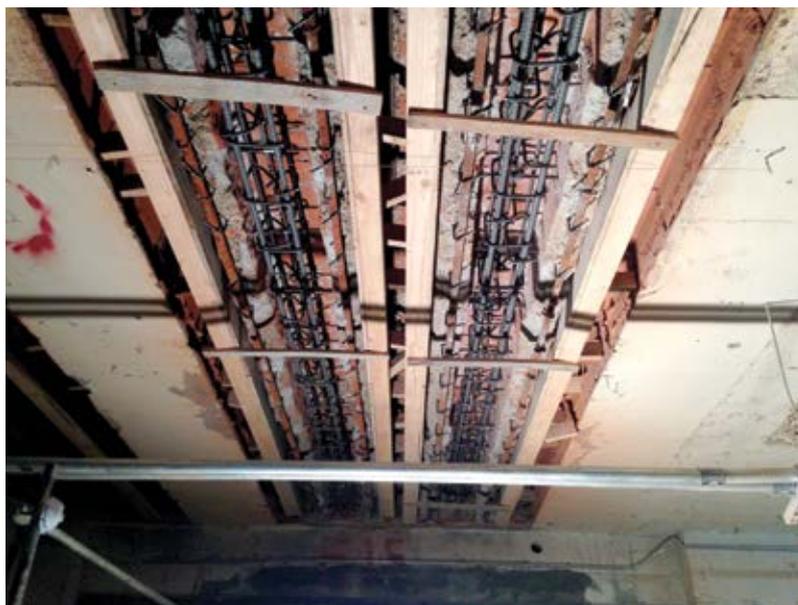
Fig. 2: This is a prepped area prior to shooting; sound existing reinforcing bar was left in place and reinforced with new reinforcing bar and dowels. The edge form was set to bind the sides of the joist infill

The objective of this rehabilitation was to chip out spalled and deleterious concrete, remove and repair corroded reinforcing bar, and restore these areas with new shotcrete to prevent potential safety hazards from further spalled concrete and return the building concrete structure back to its original strength and function (refer to Fig. 2).

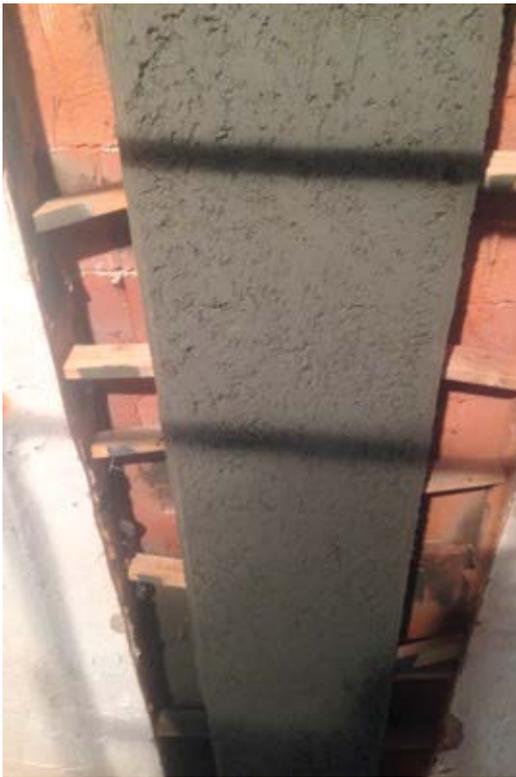
Fig. 3: The final shotcrete rod finish minimized the amount of work at the face

Thus, minimizing the out-of-service periods was crucial to the project's budgetary concerns. The shotcrete application process allowed for a way to quickly make the repairs without sacrificing the quality and safety of the finished rehabilitation (refer to Fig. 3).

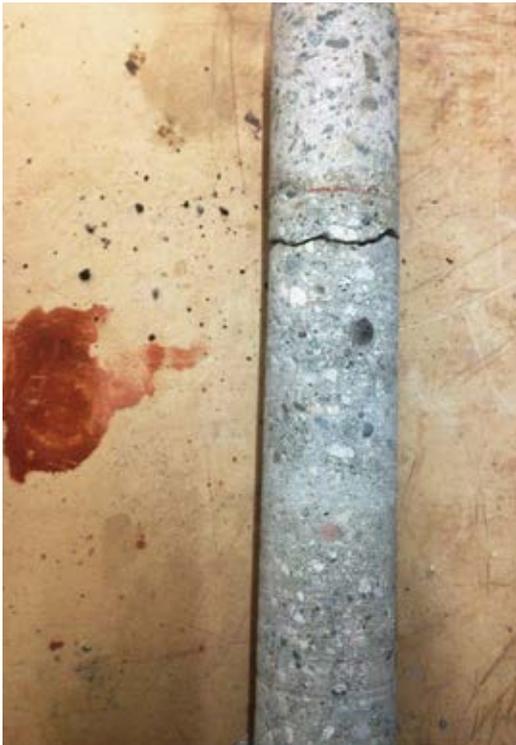
Fig. 4: A core taken from an in-place test panel. Note near the top is a faint red line—this is the tile layer seen in previous photos. In the 13 in. (330 mm) thick overhead section, ACI Certified Nozzlemen were able to achieve a solid bond without any separation between the new shotcrete and existing material. Due to the length of the core, it was not possible to drill through the length without breaking during the extraction

The overhead portion consisted of a tight lattice work of reinforcement with two horizontal No. 4 (No. 13) reinforcing bars at the top and two No. 7 (No. 22) reinforcing bars at the bottom of the beams, No. 4 (No. 13) stirrups at 12 in. (305 mm) on center, No. 4 (No. 13) reinforcing bar dowels at 12 in. (305 mm) on center with a 90-degree hook, and 5/8 in. (16 mm) diameter threaded rod at 18 in. (457 mm) on center horizontal through existing beams. The gap between existing beams was filled, creating a section totaling 13 in. (330 mm) thick and 12 in. (305 mm) wide between beams. Cores taken from repaired sections proved there was a solid bond between the new shotcrete and the existing concrete of the structure (refer to Fig. 4).

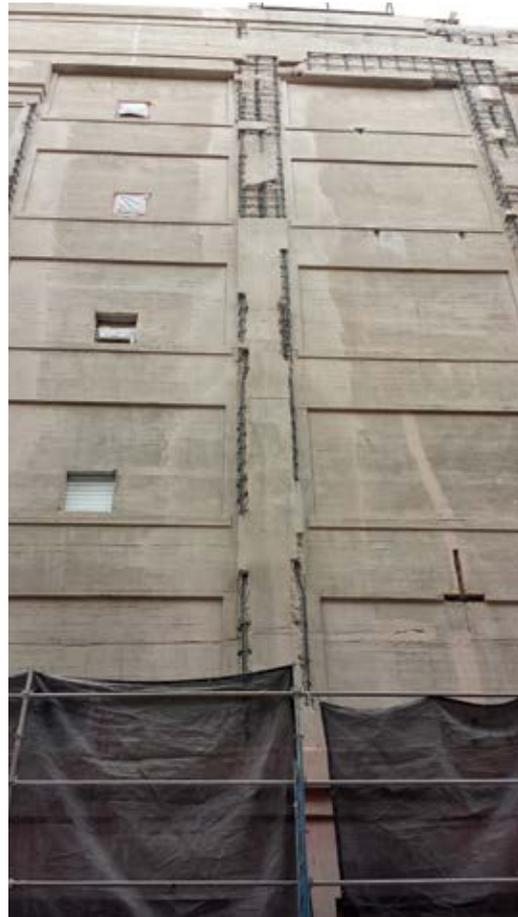
Fig. 5: The exterior façade that has been chipped back to sound material and reinforcing bar installed

size, the exterior façade repair required three aerial man lifts to provide access for the ACI Certified Shotcrete Nozzlemen and finishers (refer to Fig. 5 and 6).

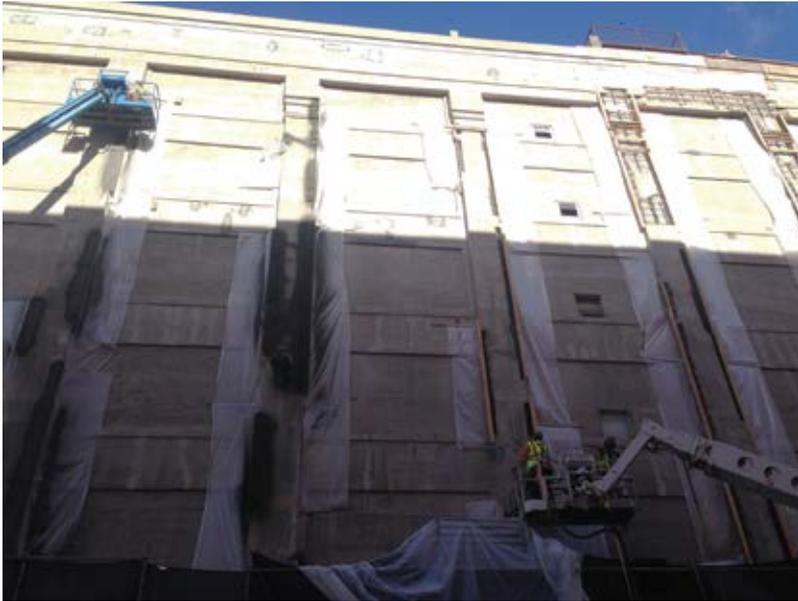
Fig. 6: The exterior façade during the shoot—several aerial man lifts were needed to properly reach the work spread over a wide area. This area was given a rubber float finish

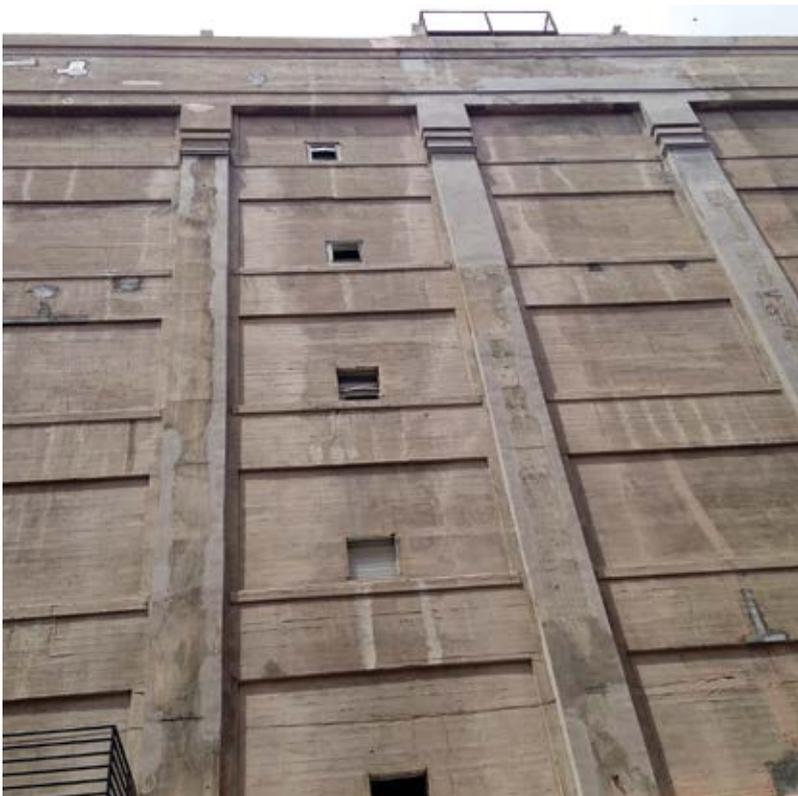
Fig. 7: The exterior façade after shotcrete operations were completed

Along with the benefits of speed and ease of overhead application, the use of shotcrete increased the sustainability of the project. The concrete mixture designs for the wet-mix shotcrete used a combination of silica fume and fly ash, which are recycled cementitious replacement materials. Shotcrete application also requires less formwork than the traditional cast-in-place concrete application, minimizing the total formwork material used for the project as well as reducing the time to place and strip the formwork. Reducing the amount of raw materials used and sourcing recycled materials for the mixture designs made the use of shotcrete over cast-in-place methods both an environmentally minded and cost-effective decision (refer to Fig. 7).
