# The Décarie Interchange Side Panel Repair Project

By Patrick Giguère and Philip Sawoszczuk

### 2010 Outstanding Infrastructure Project

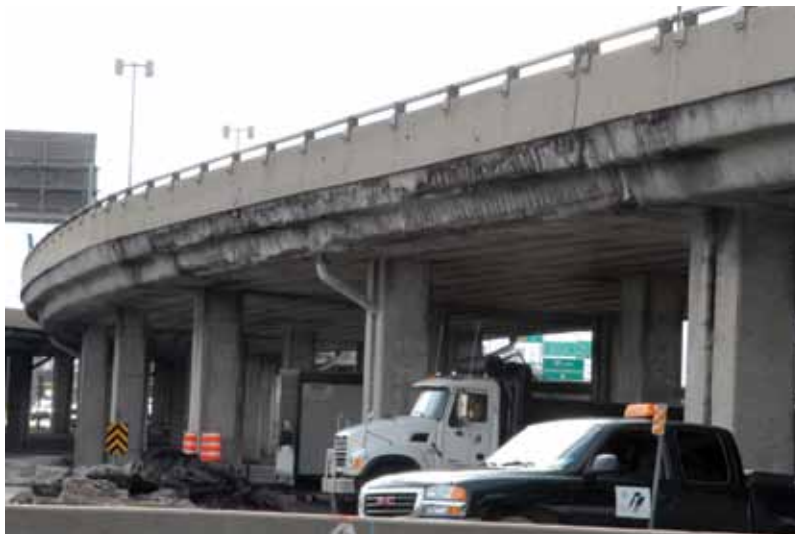
Fig. 1: The 46-year-old Décarie Interchange in Montréal, QC, Canada was showing its age

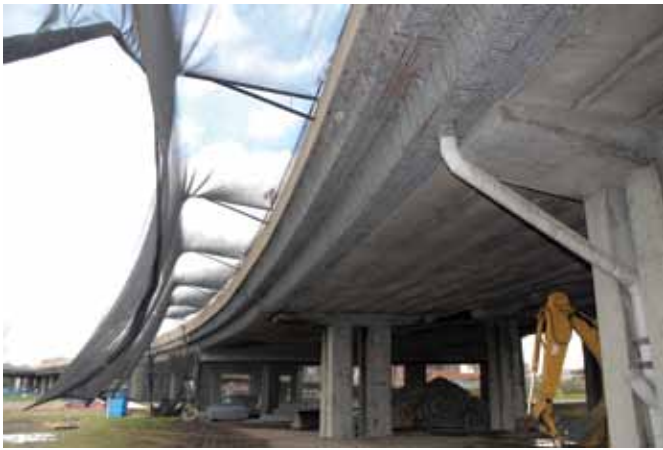
*Fig. 2: More than 4600 linear ft (1400 linear m) of repairs were required*

445 yd<sup>3</sup> (340 m<sup>3</sup>) of placed shotcrete. The material chosen for the project was the King MS-D1 Shotcrete provided by King Packaged Materials Company. The repairs totaled 4600 linear ft (1400 linear m), with some reaching 12 in. (300 mm) in thickness. In all, the contract was worth close to \$2 million CAD.

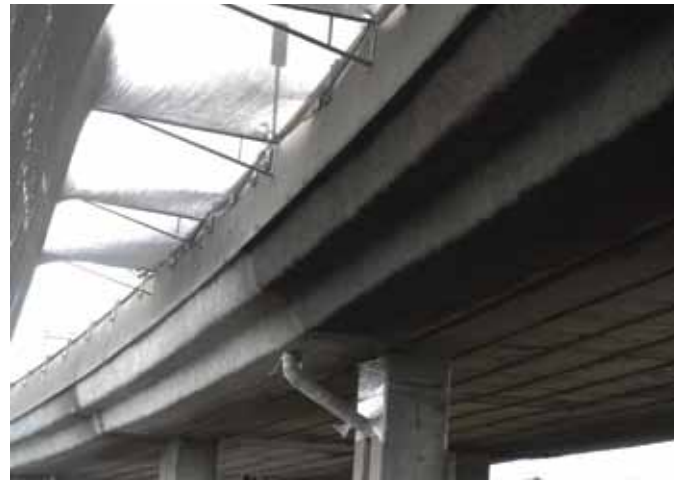
*Fig. 3: Some repairs went up to 12 in. (300 mm) in thickness*

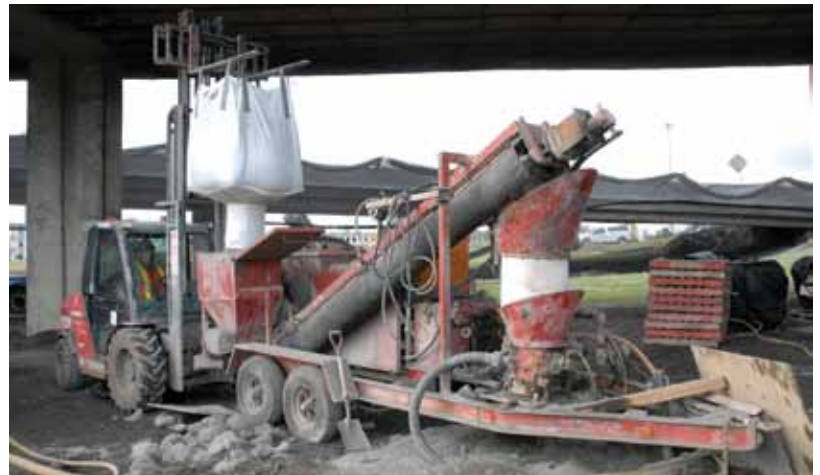
*Fig. 4: With more mobile equipment, the dry-mix shotcrete process was preferred*

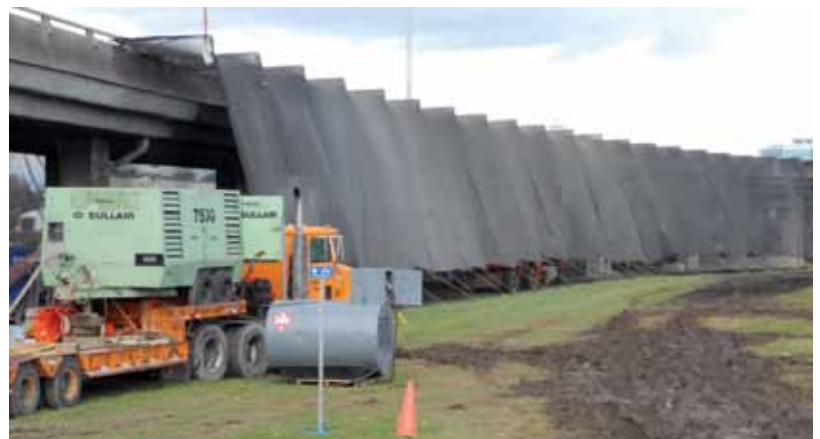
*Fig. 5: Netting protected over 280,000 vehicles per day that use the interchange*

Construction Interlag Inc. had to deal with several challenges common to transportation infrastructure projects located in heavily urbanized areas. First and foremost, the interchange serves a significant portion of Montréal's traffic and had to remain open during the repair activities. Most of the repair work was below the interchange deck, in open spaces not occupied by roads or highways, which made the placement of the smaller shotcrete equipment and material relatively simple. This notwithstanding, Construction Interlag Inc. was required to keep any stray demolished concrete debris, dust, or shotcrete spray from hitting passing vehicles and potentially causing an accident. Therefore, the MTQ required netting to be placed to shield traffic from the risk of stray material. The installation of the netting used involved fastening steel A-frame supports to the parapets of the interchange. The dark

netting was attached to the A-frames and the parapet. Secondly, moving from one end of the site to another in a straight path was impossible, as one would cross several spans of road and highway. Therefore, the work was organized to avoid too much movement. King Packaged Materials Company's shotcrete materials were placed in several locations on site where repair

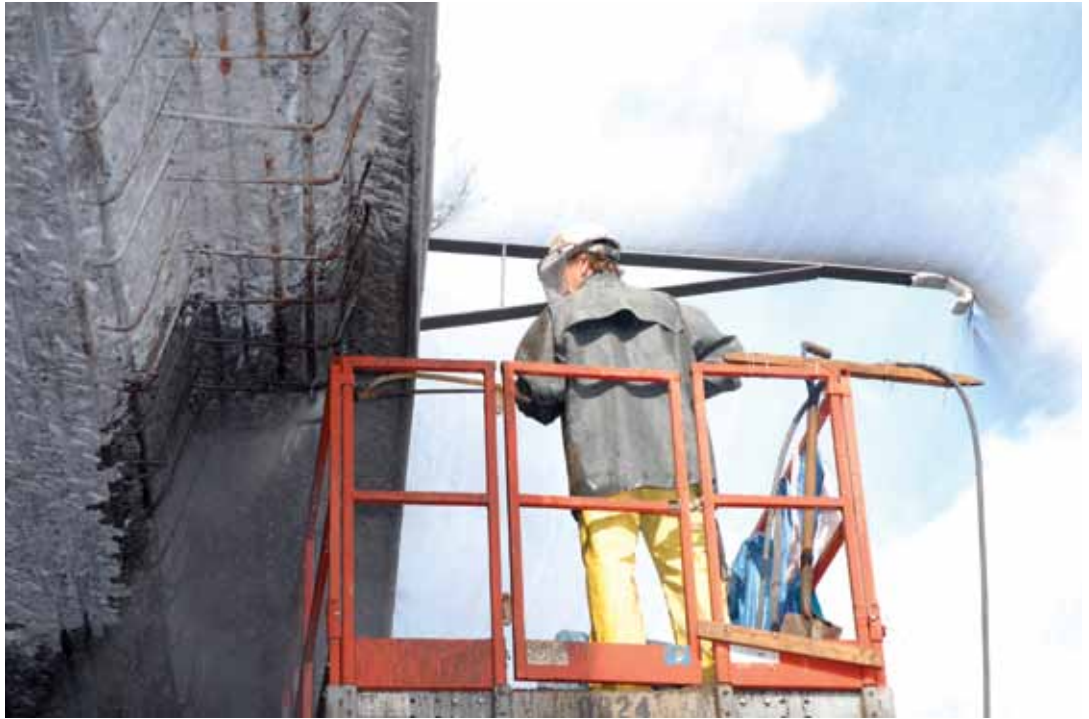
*Fig. 6: The nozzleman is battling the “wind-tunnel effect”*

The Décarie Interchange has hundreds of rectangular columns and a relatively thin deck that is coupled with open spaces located around and beneath its ramps, creating an ideal environment to channel wind and increase its speed. In other words, Construction Interlag Inc. had

to deal with the “wind-tunnel effect” as well. Higher wind speeds increased the difficulty in shooting quality shotcrete. A shotcrete mixture containing an excellent gradation, satisfying ACI Gradation No. 2, and including larger aggregates, such as 3/8 in. (10 mm) stone, helped increase efficiency, especially in windy conditions. Furthermore, an air compressor with a sufficient flow rate ensured that the material was travelling at the optimum speed to reduce dust production and rebound, and improve compaction.

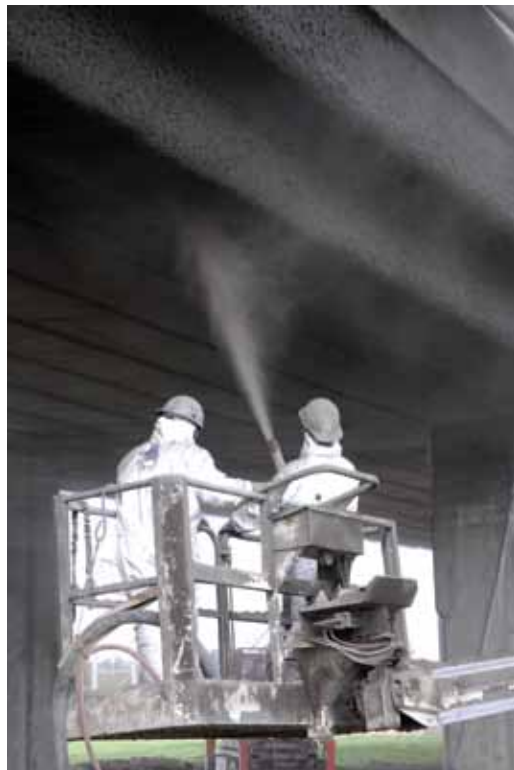
*Fig. 7: A repair zone is blasted to clean the reinforcing bar and the substrate*

By following ACI 506R-05, “Guide to Shotcrete,” and having ACI Certified Shotcrete Nozzlemen, Construction Interlag Inc. was able to overcome the traffic and high winds to successfully repair the Décarie Interchange. The Allentown shotcrete equipment used was of the rotary barrel gun type, coupled with an Allentown predampener and an air compressor. The shotcrete was always shot between 50 and 77°F (10 and 25°C), as specified by Transports Québec. The perimeters of the repairs were saw cut to eliminate feathered edges. Deteriorated concrete was removed, using pneumatic hammers sufficient to remove any deleterious substrate, while minimizing damage to the sound concrete. The unsound concrete was removed leaving a minimum of 1 in. (25 mm) of space behind the first layer of reinforcing bar. The repair surface was cleaned with high-pressure water and sandblasting. A welded-wire steel mesh was securely fastened to the reinforcing bar and anchored to the parent concrete to eliminate vibration during shotcrete application. Prior to the shotcrete application, clean water was sprayed onto the surface to obtain a saturated surface dry (SSD) condition for improved bond strength of the repair.

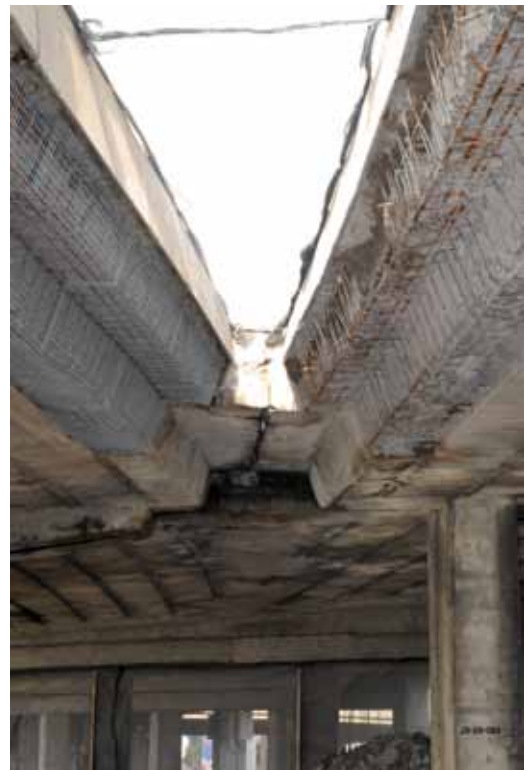
*Fig. 8: Welded-wire steel mesh conforms to the stepped trapezoidal cross section*

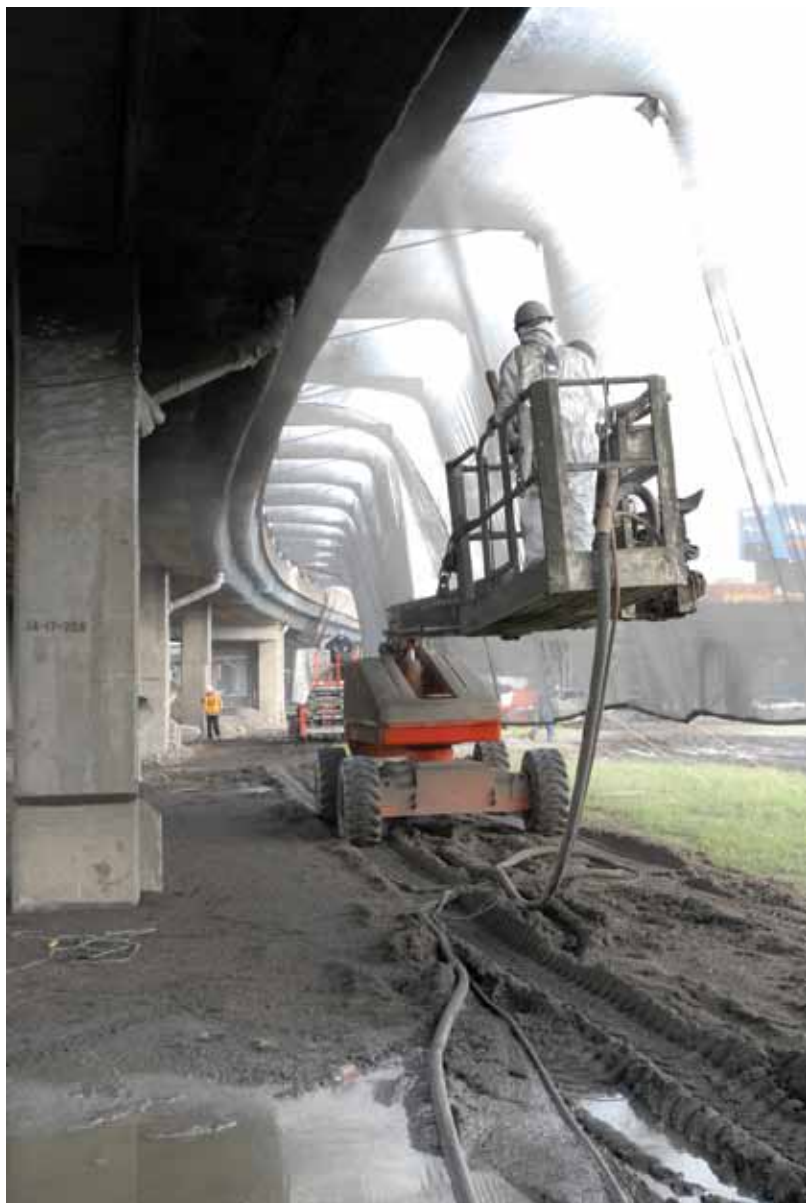
Fig. 9: Applying shotcrete from a distance of 2 to 6 ft (0.6 to 1.8 m)

King Packaged Materials Company’s MS-D1 Shotcrete was then carefully applied according to ACI 506R-05, while also accounting for variable environmental factors such as wind and rain. The mixture design met all MTQ requirements, including the specified air void spacing factor of less than or equal to 300  $\mu\text{m}$ , with no singular value exceeding 320  $\mu\text{m}$ , as tested with ASTM C457. The air entrainment of the dry-mix shotcrete was critical on this project to provide superior freezing-and-thawing durability and also a high resistance to scaling caused by deicing salts—two major causes of concrete deterioration in a northern climate. A manlift was used to maintain the optimum distance and position between the nozzle and the repair—that is, between 2 and 6 ft (0.6 and 1.8 m)—and roughly perpendicular. The shotcrete was applied in the optimal number of layers to not exceed the plastic shear resistance

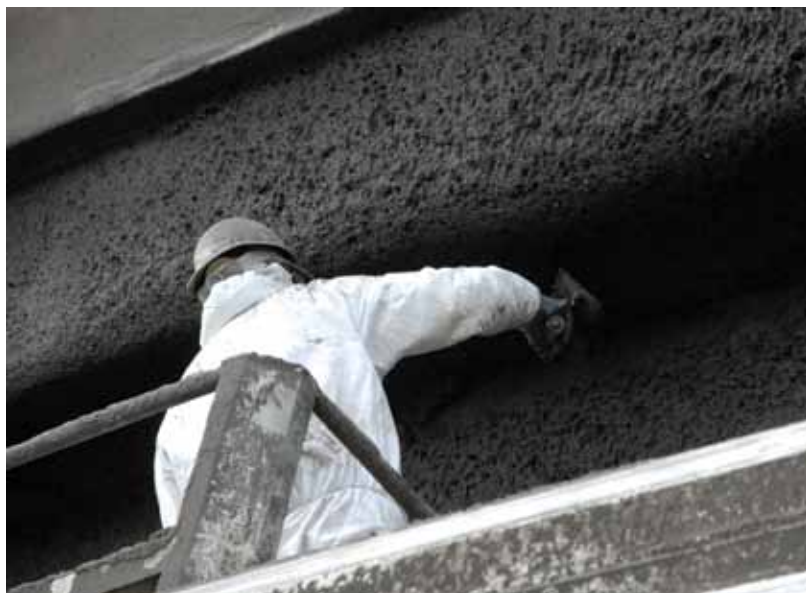
Fig. 10: The rough finish was achieved with a steel trowel

of the material, thus avoiding fallouts or repair deboning. Good reinforcing bar encapsulation was also carefully executed. The rough finish of the shotcrete repair was done with a steel trowel and the final finish was achieved with a wood float. Finally, a liquid curing agent conforming to ASTM C309 was applied immediately after finishing to ensure adequate curing, as specified by Transports Québec for overhead repairs.
