The 606-Bloomingtondale Trail | Viaduct Repairs

Shotcrete Segment of Project Overview

The Outstanding Repair & Rehabilitation Project

606-Bloomingtondale Trail | Viaduct Repairs

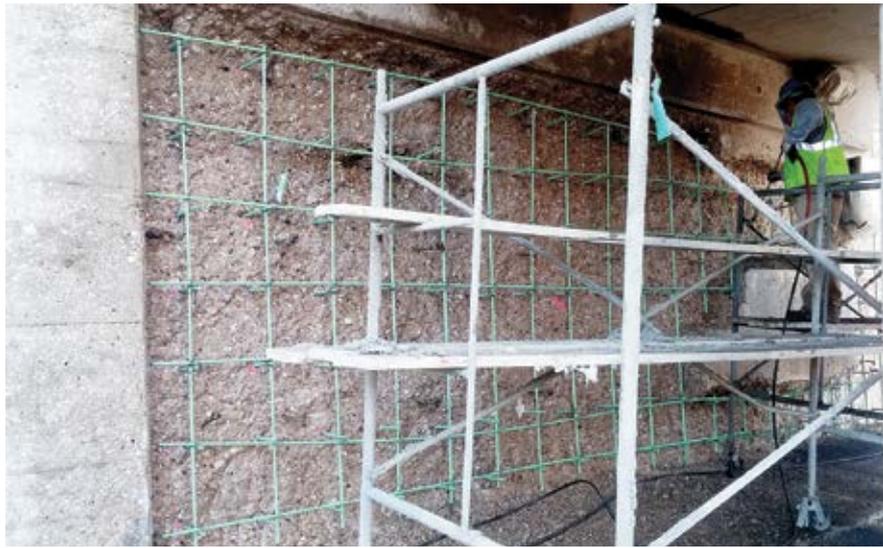
Fig. 1: Repair areas were found to be not only much larger in the field but also deeper than was called out on the plans and also lacking any reinforcing bar

With frost already present and frigid cold temperatures soon to be upon Chicagoland, ACR devised a plan to keep the project moving forward through the winter months. This plan consisted of performing the necessary concrete removals at the bridge locations followed by fully enclosing and heating the structures for shotcrete work to proceed. Along with a late start in the year and the cold weather setting in quickly, this project had a variety of obstacles, including access into heavily congested neighborhoods and residents' properties, repairs during limited closures of main thoroughfares, and a structure that was in much worse shape than originally anticipated (Fig. 1).

Upon commencement of the project, ACR realized that the bridges were in far worse condition than shown on the plans. Quantities immediately began increasing, as did the depths of the repairs, due to the fact that these walls were constructed with 1 in. (25 mm) unwashed river rock aggregate and without reinforcing steel. It was imperative to maintain excellent communication with the general contractor and the owner's engineers to verify work to be done and any additional repair steps to be taken, such as the addition of reinforcing bar, shoring, and identifying areas of complete deterioration requiring full replacement.

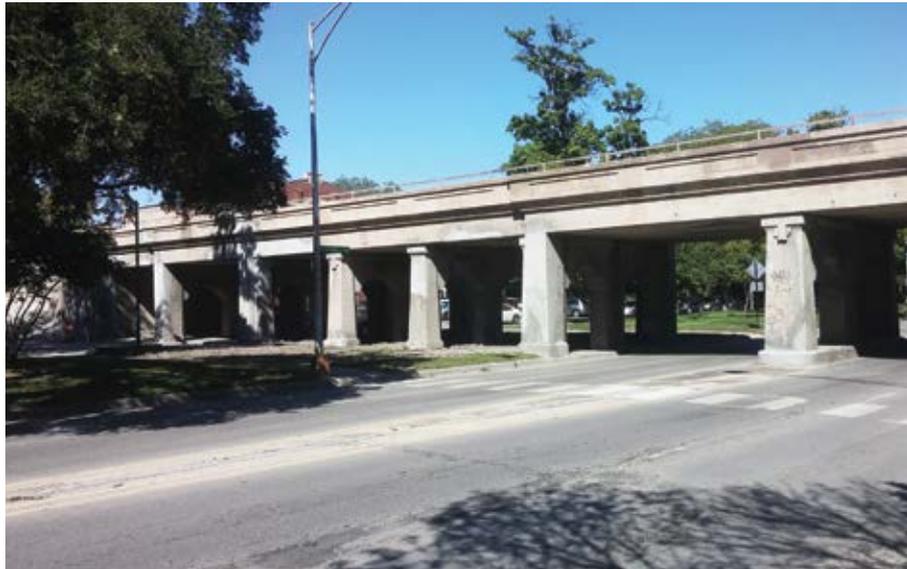
Fig. 2: Repaired 11 piers spanning 250 ft (76.2 m) over six lanes of traffic

encompassed the entire substructure including the wing walls, abutments, columns, and parapets. Each of the 36 bridges crossed two-lane streets, had three piers, and 15 columns. The trail also crossed five arterial streets, each with four lanes of traffic. At these locations there were four piers and 20 columns. At the longest bridge crossing, Humboldt Park Boulevard, it crossed six lanes of traffic, and there were 11 piers and 33 columns (Fig. 2).

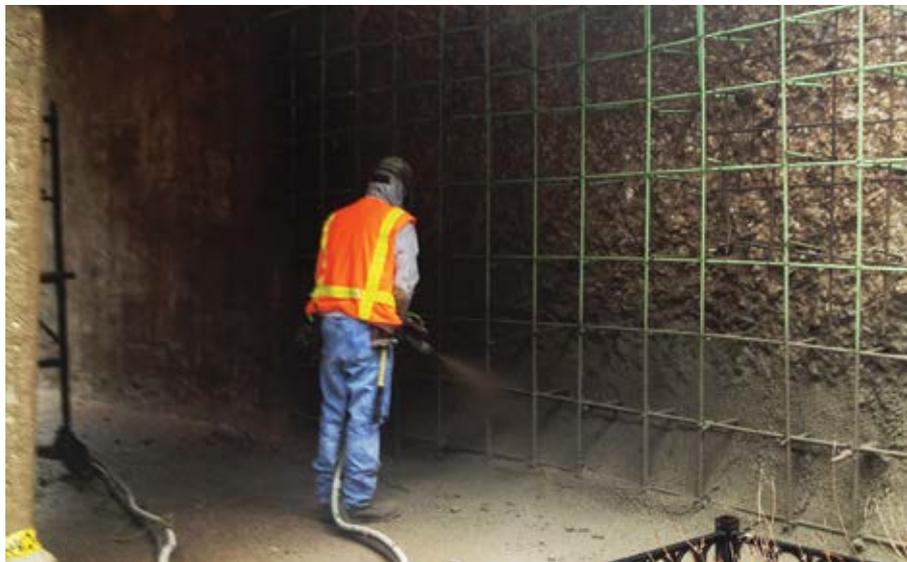
Fig. 3: ACI Certified Nozzleman shotcreting newly-reinforced repair areas

Due to the congestion of the work area and the proximity to neighboring homes, parks, and schools, ACR sandblasted with water to keep dust to a minimum. ACR also cleaned up their work area at the end of every day to prework conditions, thus leaving the neighborhood safe for pedestrians and vehicle traffic (Fig. 3).

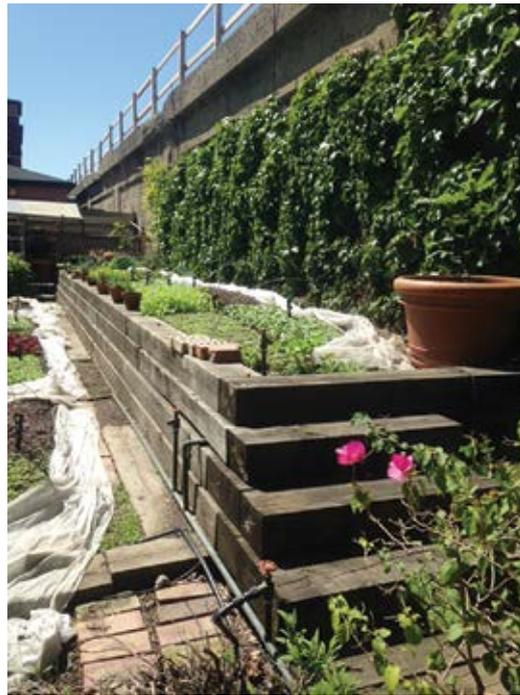
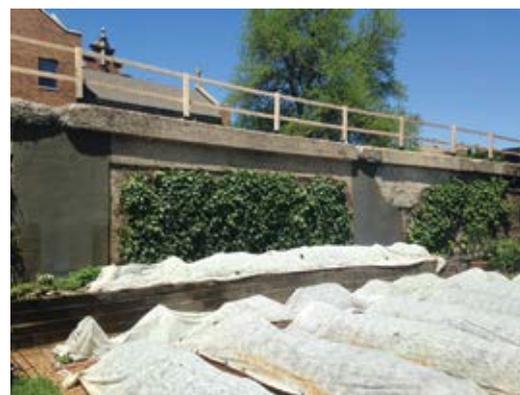
Fig. 7: Elaborate gardens of homeowners required covered repair areas that needed thorough planning, preparation, and coordination

Specifically, one of the yards ACR needed to access housed a picturesque koi pond and an herb garden owned by a well-known chef. This garden is closely tended by a professional gardener, and the harvest is used in several restaurants (Fig. 7). Thus, ACR had to deploy multiple levels of protection for the plants and planters from dust, debris, and overspray. Further, the retaining wall next to this garden was covered in decorative vines, and ACR had to coordinate with the chef's gardener to ensure proper pruning or removal without unnecessary damage to the surrounding foliage. In other areas, ACR had to install temporary framing on the outer edge coupled with protective mesh and tarps to ensure that the shotcrete work was not damaging homes and yards. ACR also encountered an area of retaining wall where the cap was directly above a residential balcony. To perform removals and shotcrete repairs without damaging property below, two stages of protection were deployed. First, ACR installed a fabric tarp along the guardrail of the trail to keep debris from travelling over the side. Additionally, the area designated for repair was framed to ensure that all chipping debris would remain on the trail-side instead of falling to the balcony and property below. This one-sided formwork also gave the nozzleman something to shoot against. As ACR progressed along this 2.67 mile (4.29 km) jobsite, encountering different temperaments of residents, gaining permission to access the repair areas along the retaining walls ran the spectrum of difficulty.
