# Advances in Shotcrete Technology for Infrastructure Rehabilitation

by Dudley R. "Rusty" Morgan

*This paper was first presented at the Concrete Institute of Australia, 22nd Biennial Conference, Concrete 05, Melbourne, October 17-19, 2005, and is republished with their authorization.*

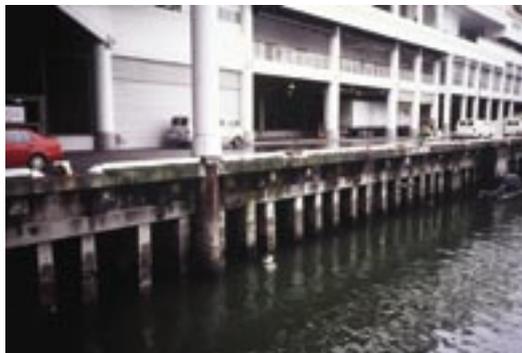
*Fig. 1: Dry-mix shotcrete repaired beams at Canada Place*

Between 1983 and 1985, approximately \$1.7 million (CAN \$2 million) was spent in the shotcrete repair of Pier B-C in Vancouver Harbor, which presently supports the Canada Place Trade and Convention Center and Pan Pacific Hotel.<sup>4</sup> Dry-mix shotcrete was used to repair deteriorated cast-in-place reinforced concrete seawalls, pile caps, beams, stringers, and deck slab soffits. The work was started using a conventional plain dry-mix shotcrete. Due to the need for enhanced productivity when working in intertidal zones, however, silica fume was subsequently employed in the mixture. This resulted in improved adhesion and cohesion and resistance to sagging and sloughing, as well as excellent wash-out resistance of the freshly applied shotcrete. Figure 1 shows a view of the shotcrete repaired beams. This pioneering project marked the first use of silica fume in dry-mix shotcrete for remedial

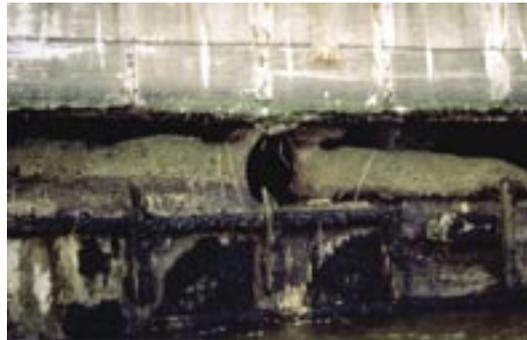
Fig. 2: Typical deterioration in 60-year-old berth faces at Port of Saint John, New Brunswick, caused by frost, alkali aggregate reactivity, and tidal/wave action

In 1986, an annual repair program for berth faces at the Port of Saint John, New Brunswick, was initiated and subsequently continued for over 10 years.<sup>5</sup> Deterioration of the mass concrete berth faces was caused by an aggressive environment including mechanical damage from ship impact, exposure to strong currents laden with salt and abrasive sediments, alkali-aggregate reactivity, and most significantly, between 200 to 300 freezing-and-thawing cycles per year over a 28 ft (8.5 m) tidal range. Figure 2 shows a typical damaged section of original concrete berth face. Between 1986 and 1996, approximately 5250 ft (1600 lineal meters) of the 33 ft (10 m) high berth face were

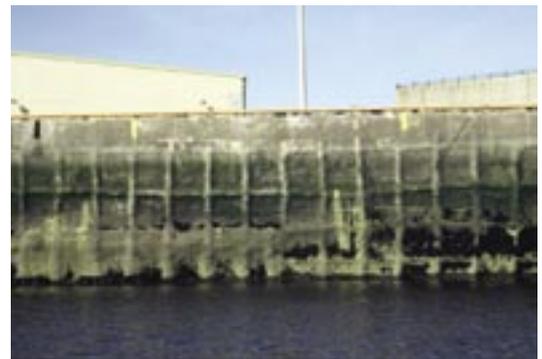
Fig. 3: View of shotcrete repaired berth faces at the Port of Saint John after 10 years in service and over 2000 freezing-and-thawing cycles

Actual compressive strengths were in the 5800 to 7250 psi (40 to 50 MPa) range at 28 days and values of boiled absorption ranged between 3.5 and 8.3%. Air void spacing factors were typically less than 0.010 in (260 μm). A condition survey conducted in 1995 revealed that the shotcrete had excellent freezing-and-thawing durability after exposure to over 2000 freezing-and-thawing cycles and was generally in very good condition in such a harsh marine environment.<sup>6</sup> Other than for some restrained shrinkage cracking and peeling type delaminations at featheredged joints, there was little deterioration of the shotcrete. Figure 3 shows a view of berth faces after 10 years in service.

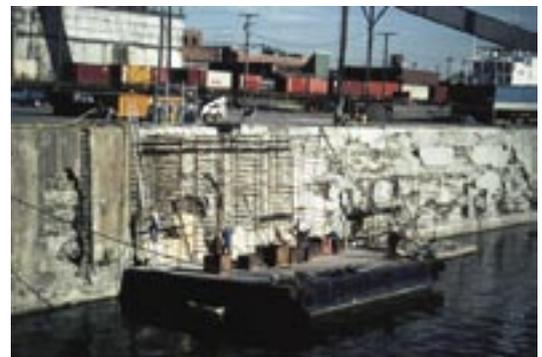
Fig. 4: Removal of deteriorated berth face concrete at Port of Montreal, Quebec

In 1995, a prototype repair program was undertaken of berth faces at the Port of Montreal in the St. Lawrence River.<sup>7</sup> The combined effects of frost damage, alkali-aggregate reactivity, and deicing chemical attack had caused severe deterioration of the original concrete structure. In some places, the concrete was turning into rubble. Repairs were carried out by removing disintegrated material, as shown in Fig. 4, and applying a tied-back and anchored wet-mix, air-entrained, silica fume shotcrete. Approximately two-thirds of the berth

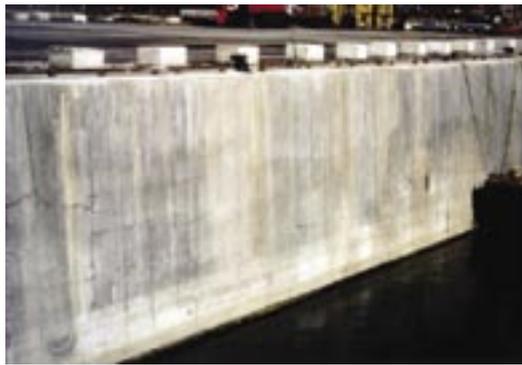
Fig. 5: Portion of the completed wet-mix shotcrete repairs to berth face at the Port of Montreal

face, 400 ft (122 m) long and 23 ft (7.1 m) high, was repaired using 19.2 lb/yd<sup>3</sup> (11.4 kg/m<sup>3</sup>) of polyolefin fiber-reinforced shotcrete. The remaining third of the berth face was repaired using 101 lb/yd<sup>3</sup> (60 kg/m<sup>3</sup>) of steel fiber-reinforced shotcrete. Figure 5 shows a portion of the completed works. The shotcrete has performed well, and the comparative behavior of the steel and polyolefin fiber-reinforced shotcrete sections is being monitored.

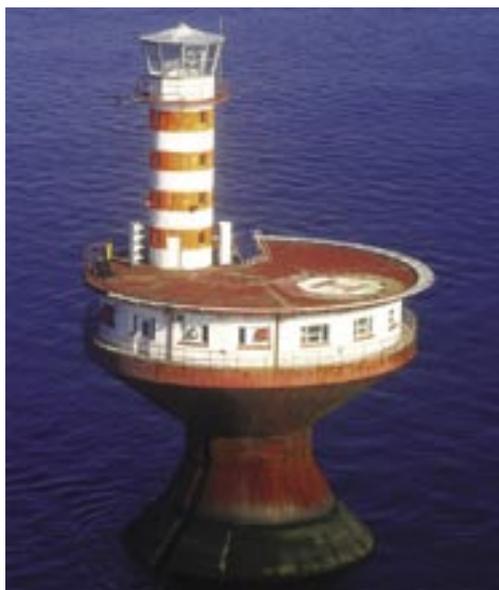
Fig. 6: Haute-Fond Prince Lighthouse in Gulf of St. Lawrence, Quebec, after completion of shotcrete repairs

The shotcrete applied readily met the specified performance requirements and the parameters of the air void system indicated that the shotcrete should be resistant to damage from freezing and thawing in this chloride-laden environment. Figure 6 shows a view of the shotcrete repaired lighthouse. Examination of the lighthouse after 4 years in service demonstrated that the repairs were displaying excellent resistance to damage from freezing-and-thawing cycles, erosion, and impact from ice.

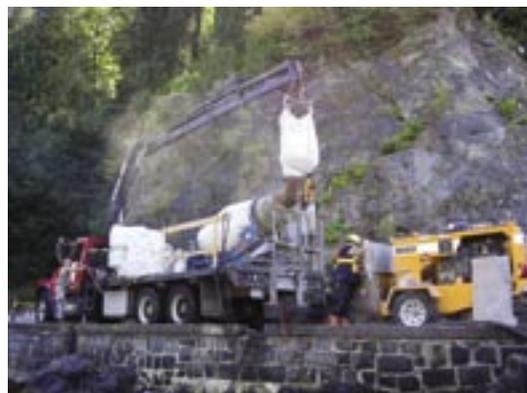
Fig. 7: Shotcrete "train" on the Stanley Park Seawall, Vancouver, BC

The shotcrete was supplied in 1763 lb (800 kg) bulk bin bags that were discharged into a 2.6 yd<sup>3</sup> (2 m<sup>3</sup>) tilting drum mixer mounted on a flatbed truck. All shotcrete equipment and materials were mounted on a shotcrete train that moved along the seawall performing the underpinning repairs where required. Figure 7 shows a view of the shotcrete train. On relatively calm days, when there was no major wave action, the contractor was able to continue shotcreting until about half an hour before the incoming tide reached the work, with no washout or detrimental effects on the shotcrete.

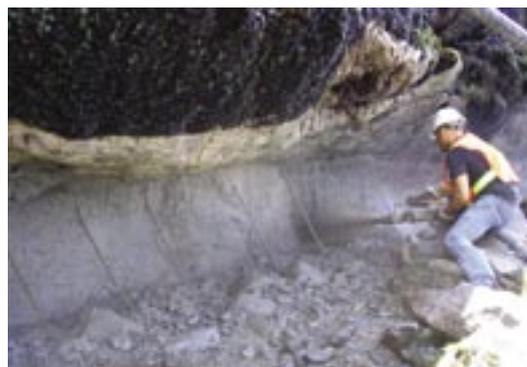
Fig. 8: Underpinning of a cave under the seawall near Siwash Rock, Stanley Park Seawall, Vancouver, BC, using macrosynthetic fiber-reinforced wet-mix shotcrete

of the seawall has demonstrated remarkable durability, considering its age and the exposure conditions. By 2000, however, there were numerous locations, comprising approximately 1640 ft (500 m) in total length, where waves and tidal action had caused scour and erosion, undermining the seawall. Figure 8 shows one such location near Siwash Rock where scour and erosion from wave and tidal action had created a cave in the sandstone under the seawall.

On windy days, shotcreting work was terminated about an hour before the incoming tide reached the work. The most challenging area to shoot was the cave at Siwash Rock. It had to be filled in three passes to a total thickness of about 8.2 ft (2.5 m). Figure 8 shows this work in progress. Figure 9 shows shotcrete repairs to damaged concrete-faced rip-rap in the Devonian Park part of the seawall in Coal Harbor. This project was completed on time and on budget to the satisfaction of all in a challenging working environment of tidal and weather constraints and public and environmental scrutiny.

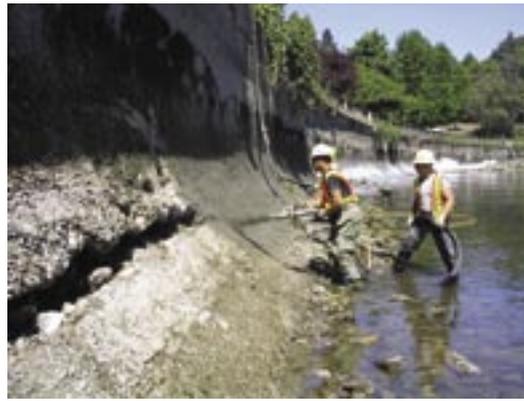
*Fig. 9: Shotcrete repairs to damaged concrete-faced rip-rap in the Devonian Park part of Stanley Park Seawall*

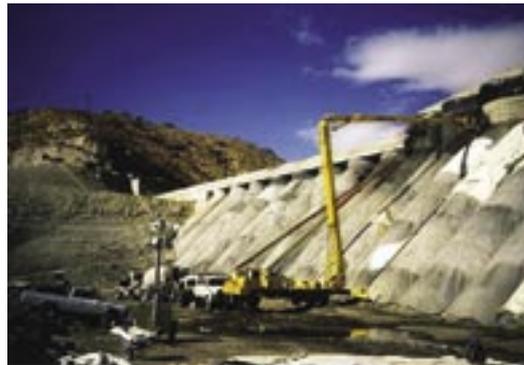
*Fig. 10: Seismic retrofit of the upstream face of the Little Rock Dam*

In 1994, a major seismic retrofit program was carried out on the Little Rock Dam in southern California.<sup>10</sup> This multiple-arch dam provides vital water supply for both the Palmdale Water District and the Little Rock Creek Irrigation District. Its location just 1.5 miles (2.4 km) south of the San Andreas fault raised concerns about the adequacy of the dam and its stability in the event of an earthquake. To provide seismic strengthening, air-entrained, silica fume modified, steel fiber-reinforced, wet-mix shotcrete was applied at a nominal thickness of 4 in. (100 mm) over 48,420 ft<sup>2</sup> (4500 m<sup>2</sup>) surface area, together with over 3400 anchors. Figure 10 shows shotcrete retrofit on the dam face in progress. Quality control testing indicated excellent shotcrete performance (compressive strength, bond pull-off strength, consolidation, toughness, boiled absorption and volume of permeable voids). Upon completion of the project, the shotcrete was observed to be essentially crack free, in spite of the work being completed in a desert climate, where the ambient temperatures rose as high as 104 °F (40 °C) during the daytime and by project end fell below zero at night. The work was successfully completed on time and within budget to the satisfaction of the owner.

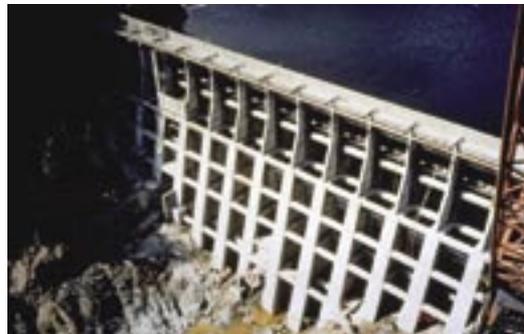
*Fig. 11: Shotcrete repairs to upper buttresses, Jordan River Dam*

The Jordan River Dam is a 131 ft (40 m) high Ambersen buttress-type dam built from 1912 to 1913 in Southern Vancouver Island, British Columbia.<sup>11,12</sup> It comprises inclined reinforced concrete slabs resting on downstream buttresses. Figure 11 shows the seismically retrofitted dam in 1990. The slabs are 4.6 ft (1.4 m) thick at the base of the dam, tapering to 1.3 ft (0.4 m) thick at the top. Over the years, the slabs and buttress elements progressively deteriorated as a result of water leaking through joints in the slabs above the buttresses, leaching, and frost action. In addition, there was some abrasion and wear on the upstream face of the dam from logs and ice abrasion as the water level in the dam

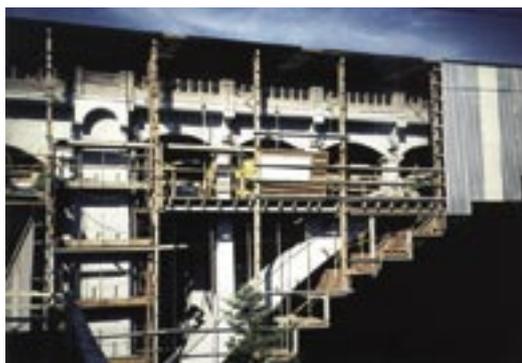
*Fig. 12: Shotcrete repaired Depoe Bay Bridge with thermal-sprayed zinc anode cathodic protection coating*

In spite of these challenges, the Depoe Bay Bridge provides an excellent example of the quality of artistic detail that can be reconstructed using the shotcrete process as can be seen in Fig. 12.

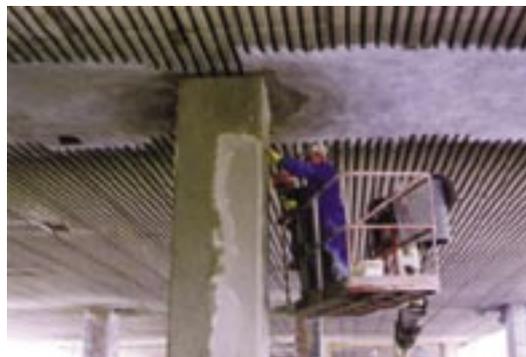
Fig. 13: Shotcrete repairs to Metropolitan Boulevard, Montreal, Quebec

In 1990, the mixture design shown in Table 7 was used for a CAN \$80 million repair of the 6.25 mi (10 km) long elevated Metropolitan Boulevard expressway in Montreal. Shotcrete repairs were made to the underside of the deck as well as over 5000 columns. After 14 years of exposure to service, severe weather, and deicing salts, the repairs are performing very well. Figure 13 shows shotcrete repair to the deck soffit and columns in progress in 1990.

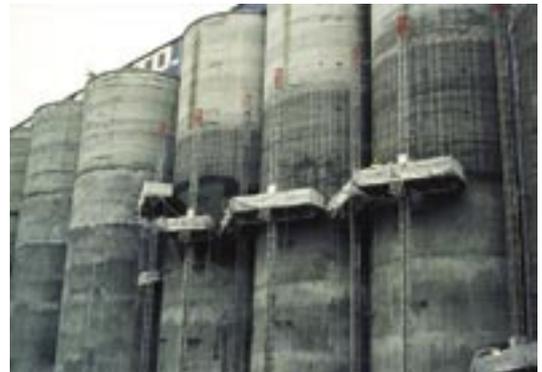
Fig. 14: Shotcrete strengthening of grain silos at Prince Rupert, BC

- Jacketing and strengthening of cracked and leaking grain silos<sup>18</sup> (refer to Fig. 14);
- Repair of corrosion damaged bulk shipping facilities such as potash, coal, and sulphur load-out dumper pits, loading towers, and conveyors;
- Seismic upgrading of heritage and other masonry and reinforced concrete structures;
- Repair and strengthening of large diameter corrugated metal culverts;
- Repair of water and sewer pipes;

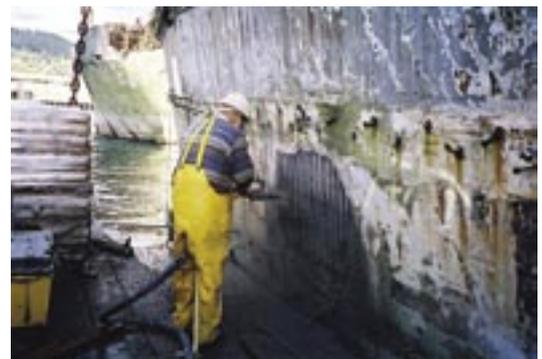
Fig. 15: Shotcrete repaired floating concrete ships, Powell River, BC

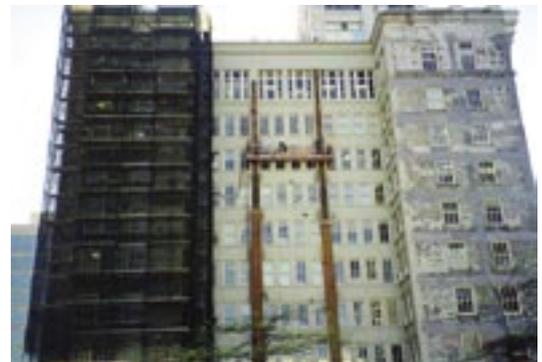
Fig. 16: Shotcrete repair of heritage building, Vancouver, BC

- Repair of deteriorated aqueducts, pressure head-race tunnels, canals, and other water conveyance devices;
- Repair of deteriorated and leaking swimming pools, water reservoirs, sumps, pits, sewage treatment facilities, and other liquid containing facilities;
- Repair of 50-year-old concrete ships now used as a breakwater at Powell River, British Columbia<sup>19,20</sup> (refer to Fig. 15); and
- Repair of a steel framed terracotta and masonry clad heritage high rise building.<sup>21</sup> (refer to Fig. 16).
