Crossing the Line

By Oscar Duckworth

Technical Tip

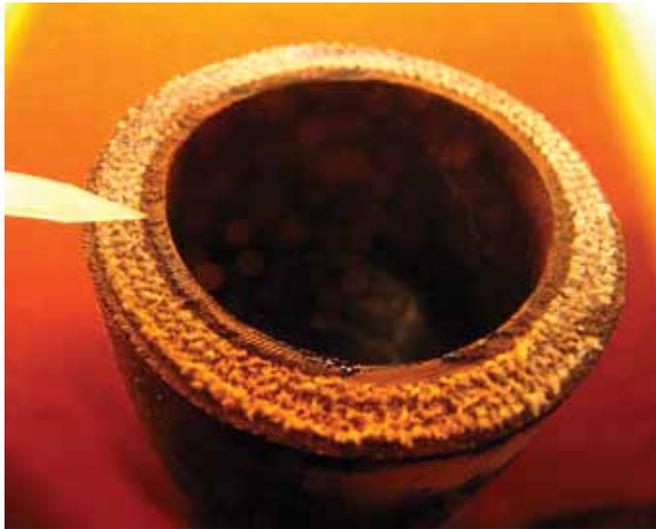
Fig. 1(a): Hose section displaying inner liner area and braided fabric cords

If a placement hose is not pressurized, but filled with concrete, it should not be run over. A placement hose's smooth inner liner can be permanently damaged by being run over, even once (Fig. 1(a) and (b)).

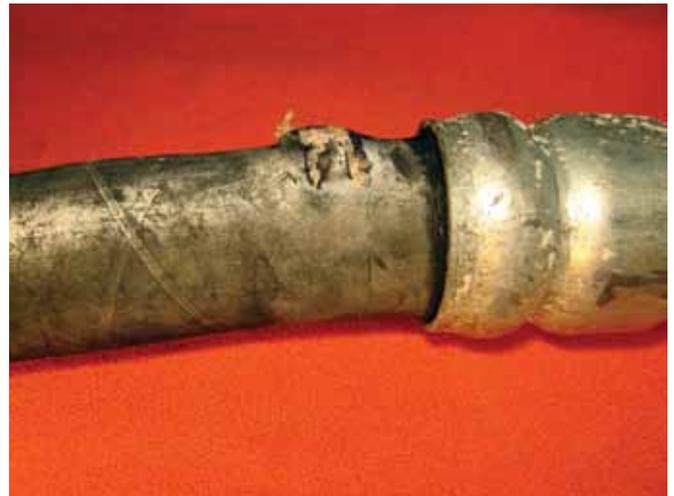
Fig. 2(a): This nearly new hose has burst within days of being run over by equipment. Note the lack of external evidence of internal abrasion damage, as seen in Fig. 2(b)

More often, the line will simply burst without warning days or weeks later, right at the point of the original damage (Fig. 2(a) and (b)).

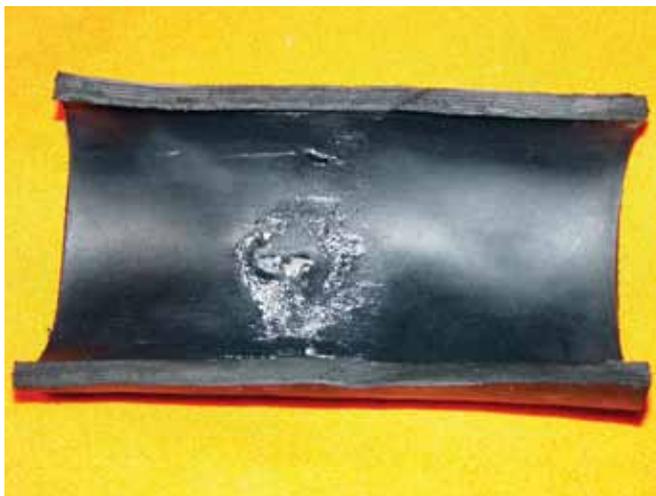
Fig. 1(b): Interior view of inner liner failure caused by crushing

Angular coarse aggregates in the shotcrete mixture can pierce the placement hose's inner liner if the hose is crushed from its exterior. A small protrusion or tear in the inner liner will allow pressurized shotcrete mixture into and through the hose's vulnerable inner braided area. Occasionally, a bubble on the hose's exterior will give a warning signal of a pierced inner liner.

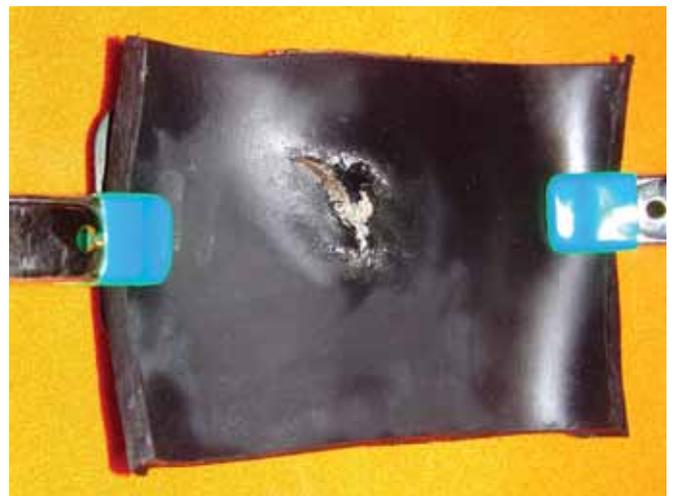
Fig. 2(b): Interior view of burst area
