Seismic Retrofit of California Memorial Stadium

By Nur Kasdi and Larry Totten

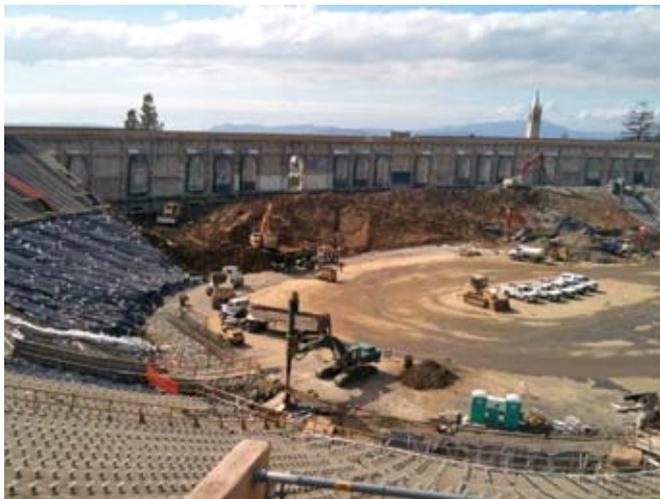
Fig. 1: Overview of the existing historic walls during demolition and excavation. A layer of shotcrete was later applied over the existing walls in various thicknesses from 5 to 36 in. (127 to 914 mm)

A unique feature to the project was that while the majority of the existing structure was demolished and reconstructed, the outer perimeter wall had to remain in place to preserve the historic landmark.

Johnson Western Gunitite (JWG), a Superior Gunitite Company, was assigned the task to install a heavily reinforced shotcrete layer over the historic wall for seismic strengthening. The shotcrete overlay varied in thicknesses from 5 to 36 in. (127 to 914 mm). Because the majority of the wall surfaces were exposed, a steel trowel finish was required. The base contract volume was approximately 4000 yd³ (3058 m³).

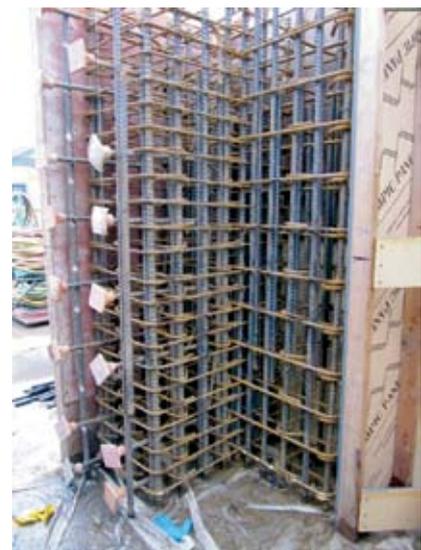
Fig. 2: Type 1 preconstruction test panel was composed of three curtains of No. 10 (No. 32M) and No. 9 (No. 29M) reinforcing steel with additional boundary reinforcing bar elements

- Type 1: A historic wall shotcrete overlay intersected with a shear wall, with three curtains of No. 10 (No. 32M) and No. 9 (No. 29M) reinforcing steel with additional boundary reinforcing bar elements each 24 in. (610 mm) thick. Refer to Fig. 1 through 3.
- Type 2: A historic wall shotcrete overlay intersected with a shear wall with an existing pilaster obstruction and three curtains of No. 10 (No. 32M) and No. 9 (No. 29M) reinforcing steel with additional boundary reinforcing bar elements each 18 in. (457 mm) thick.
- Type 3: A historic wall shotcrete overlay with an embedded existing pilaster with reinforcing steel cages 20 in. (508 mm) thick.
- Type 4: A miscellaneous interior wall with an embedded column 12 in. (305 mm) thick.

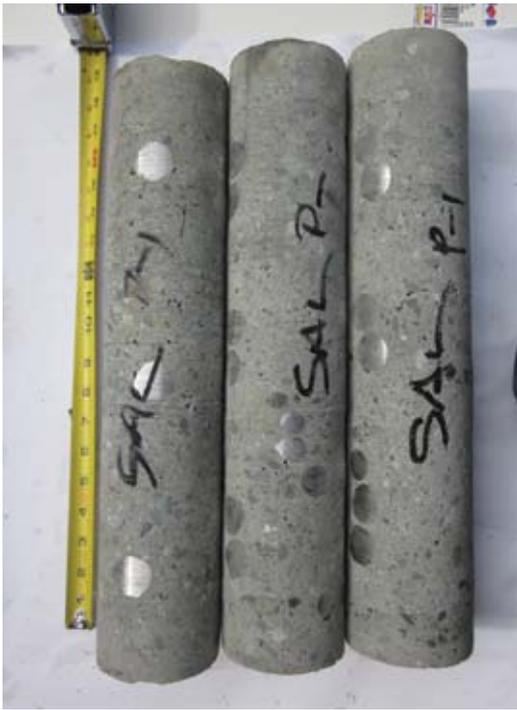
Fig. 3: Cores retrieved from Type 1 preconstruction test panel

in the project. A mean grade of 2.0 was required to pass, with no single core having a core grade exceeding 3.0. Seven of the eight nozzle men successfully passed the test. The engineer selected the following test panel conditions:

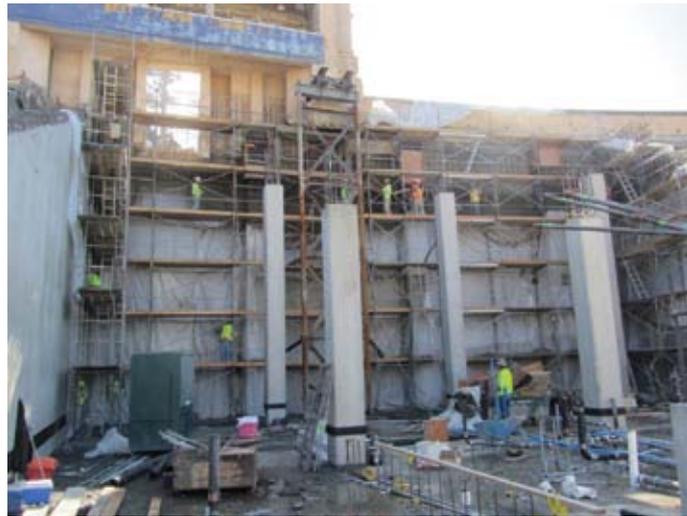
Fig. 4: Existing historic wall prior to shotcrete overlay application

The dense steel configuration motivated the JWG crew to take an unconventional approach to shotcrete application. At some locations, the actual field measurements for the historic wall overlays were over 36 in. (914 mm) thick and required full height installation of up to 40 ft (12.2 m; refer to Fig. 4 through 6). To address this problem, shotcrete was applied in 12 ft (305 mm) tall lifts. Once the concrete material set up, the next shotcrete lift was installed. Consequently, there were no major voids as a result of poor consolidation reported on the project.

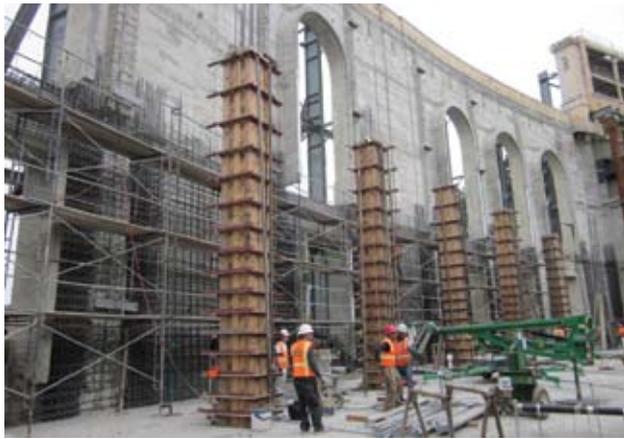
Fig. 5: Application of 40 ft (12.2 m) tall shotcrete layer 36 in. (914 mm) thick over the existing historic perimeter wall

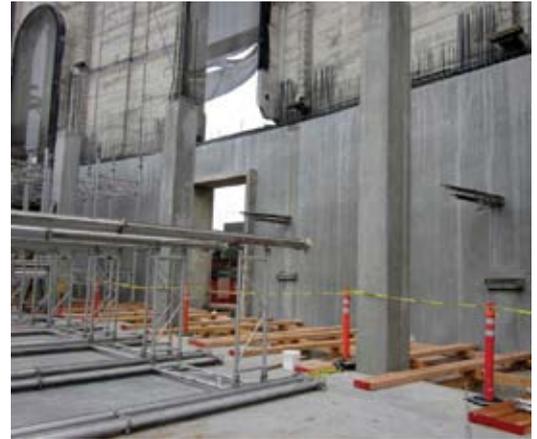
Fig. 6: Existing historic wall after shotcrete overlay application

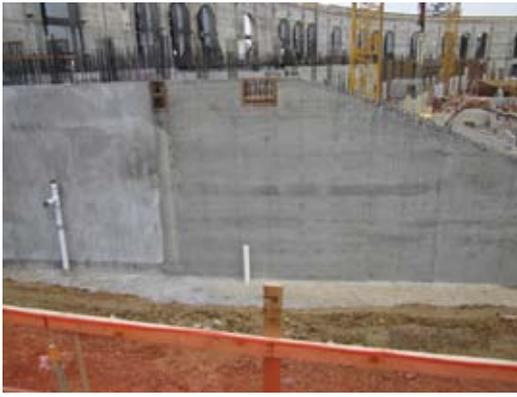
Fig. 7: Shotcrete shear wall after the forms were stripped. The right side of the wall is the stripped form side. The left side is the shotcrete steel trowel finish side

The walls were applied in one layer of scratch coat from the bottom to the top, and then the final finish coat from the top down was later applied (refer to Fig. 7). By taking this approach, JWG was able to ensure a uniform steel trowel finish. A unique experience at this project was that JWG found that the use of additional water-reducing admixture was actually detrimental to work production. As a result, JWG used a low dosage when applying a scratch finish so more concrete material could be stacked on the wall. The dosage was

increased when applying the final coat finish, which accommodated extra time for the finishers to complete their work before the concrete set.
