The Décarie Interchange Side Panel Repair Project

By Patrick Giguère and Philip Sawoszczuk

2010 Outstanding Infrastructure Project

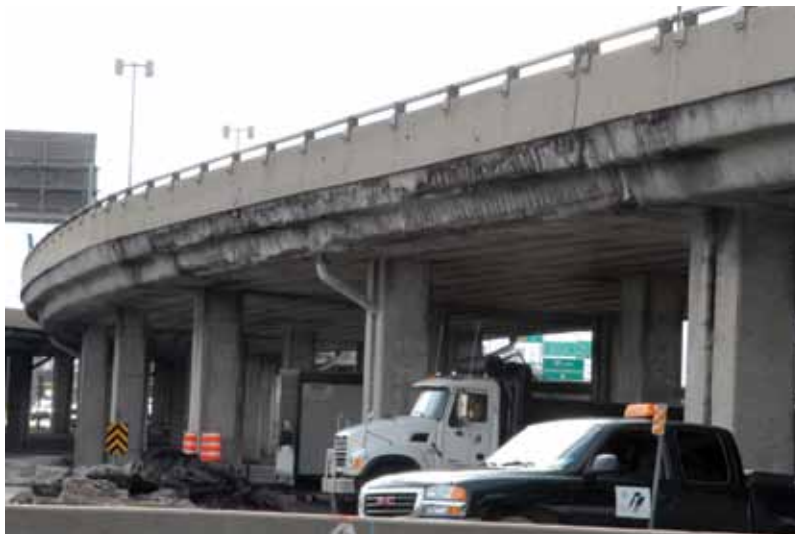
Fig. 1: The 46-year-old Décarie Interchange in Montréal, QC, Canada was showing its age

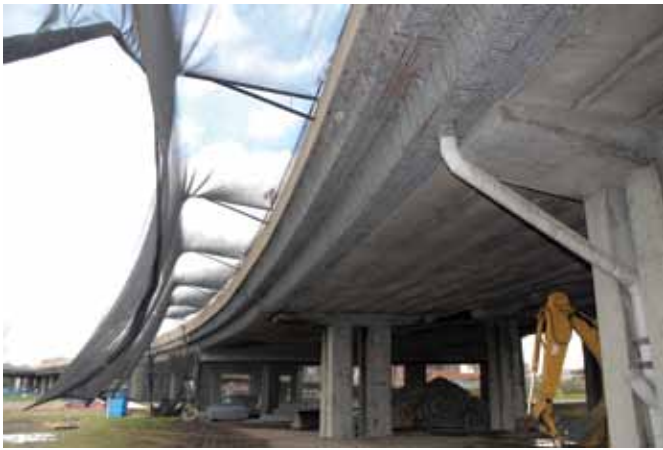
Fig. 2: More than 4600 linear ft (1400 linear m) of repairs were required

445 yd³ (340 m³) of placed shotcrete. The material chosen for the project was the King MS-D1 Shotcrete provided by King Packaged Materials Company. The repairs totaled 4600 linear ft (1400 linear m), with some reaching 12 in. (300 mm) in thickness. In all, the contract was worth close to \$2 million CAD.

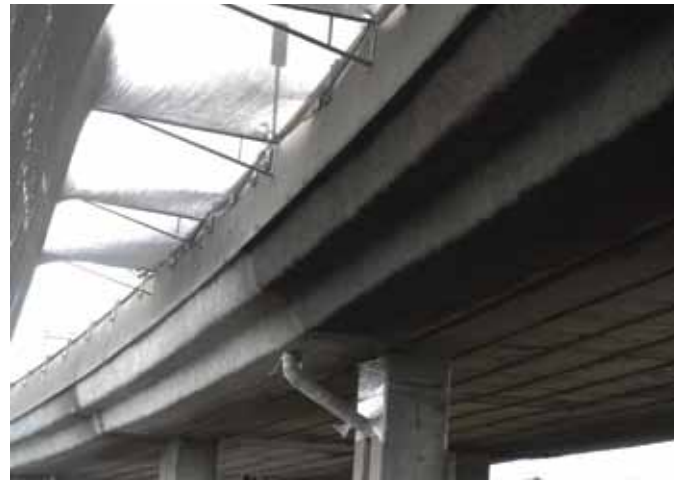
Fig. 3: Some repairs went up to 12 in. (300 mm) in thickness

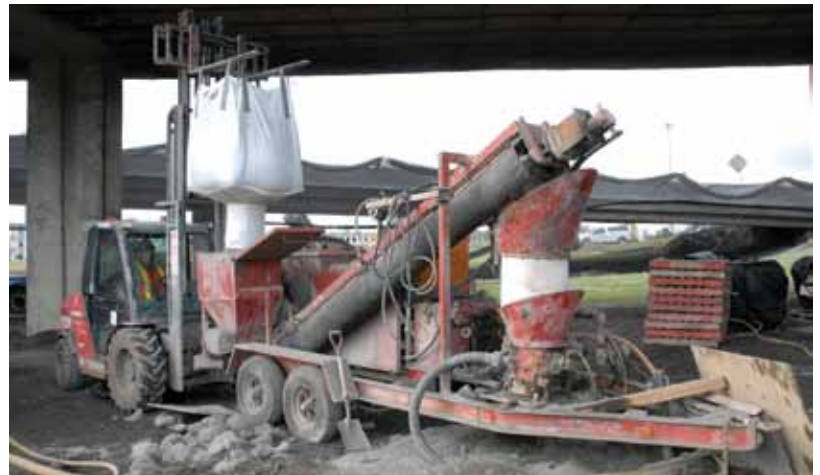
Fig. 4: With more mobile equipment, the dry-mix shotcrete process was preferred

By following ACI 506R-05, “Guide to Shotcrete,” and having ACI Certified Shotcrete Nozzlemen, Construction Interlag Inc. was able to overcome the traffic and high winds to successfully repair the Décarie Interchange. The Allentown shotcrete equipment used was of the rotary barrel gun type, coupled with an Allentown predampener and an air compressor. The shotcrete was always shot between 50 and 77°F (10 and 25°C), as specified by Transports Québec. The perimeters of the repairs were saw cut to eliminate feathered edges. Deteriorated concrete was removed, using pneumatic hammers sufficient to remove any deleterious substrate, while minimizing damage to the sound concrete. The unsound concrete was removed leaving a minimum of 1 in. (25 mm) of space behind the first layer of reinforcing bar. The repair surface was cleaned with high-pressure water and sand-blasting. A welded-wire steel mesh was securely fastened to the reinforcing bar and anchored to the parent concrete to eliminate vibration during shotcrete application. Prior to the shotcrete application, clean water was sprayed onto the surface to obtain a saturated surface dry (SSD) condition for improved bond strength of the repair.

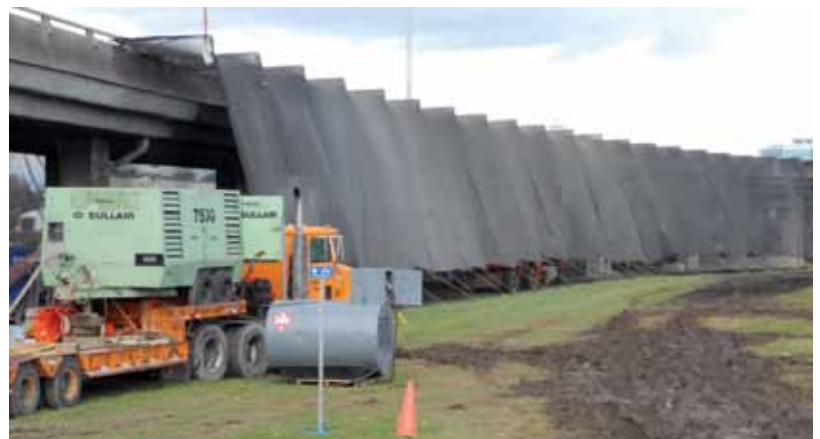
Fig. 5: Netting protected over 280,000 vehicles per day that use the interchange

Construction Interlag Inc. had to deal with several challenges common to transportation infrastructure projects located in heavily urbanized areas. First and foremost, the interchange serves a significant portion of Montréal's traffic and had to remain open during the repair activities. Most of the repair work was below the interchange deck, in open spaces not occupied by roads or highways, which made the placement of the smaller shotcrete equipment and material relatively simple. This notwithstanding, Construction Interlag Inc. was required to keep any stray demolished concrete debris, dust, or shotcrete spray from hitting passing vehicles and potentially causing an accident. Therefore, the MTQ required netting to be placed to shield traffic from the risk of stray material. The installation of the netting used involved fastening steel A-frame supports to the parapets of the interchange. The dark

netting was attached to the A-frames and the parapet. Secondly, moving from one end of the site to another in a straight path was impossible, as one would cross several spans of road and highway. Therefore, the work was organized to avoid too much movement. King Packaged Materials Company's shotcrete materials were placed in several locations on site where repair

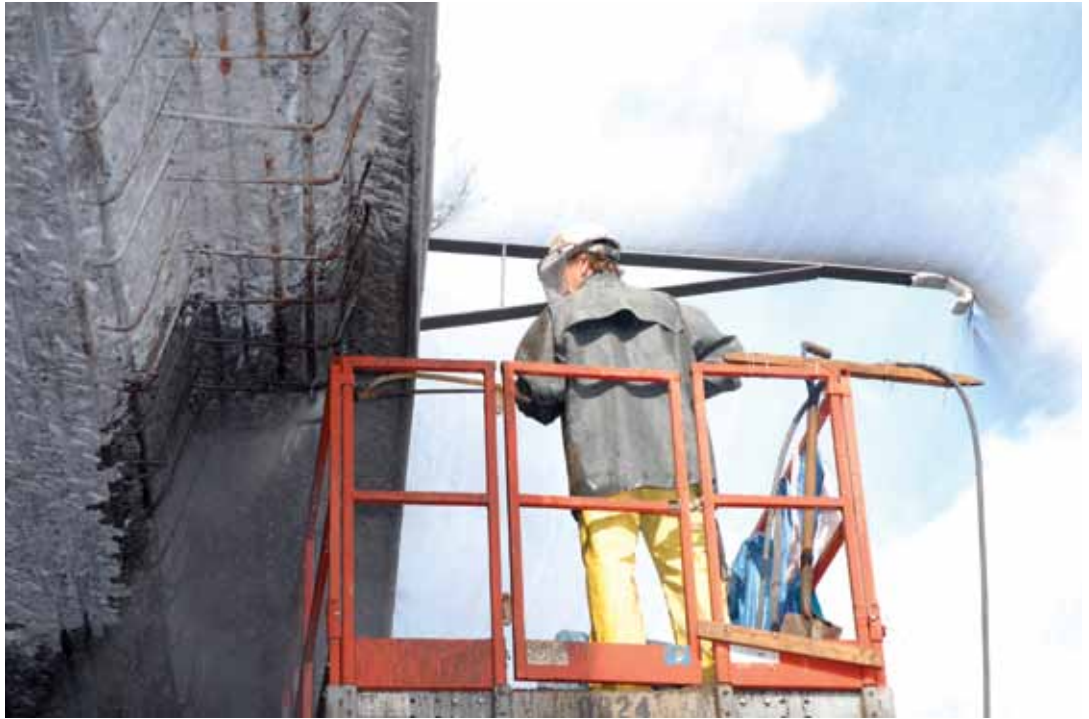
Fig. 6: The nozzleman is battling the “wind-tunnel effect”

The Décarie Interchange has hundreds of rectangular columns and a relatively thin deck that is coupled with open spaces located around and beneath its ramps, creating an ideal environment to channel wind and increase its speed. In other words, Construction Interlag Inc. had

to deal with the “wind-tunnel effect” as well. Higher wind speeds increased the difficulty in shooting quality shotcrete. A shotcrete mixture containing an excellent gradation, satisfying ACI Gradation No. 2, and including larger aggregates, such as 3/8 in. (10 mm) stone, helped increase efficiency, especially in windy conditions. Furthermore, an air compressor with a sufficient flow rate ensured that the material was travelling at the optimum speed to reduce dust production and rebound, and improve compaction.

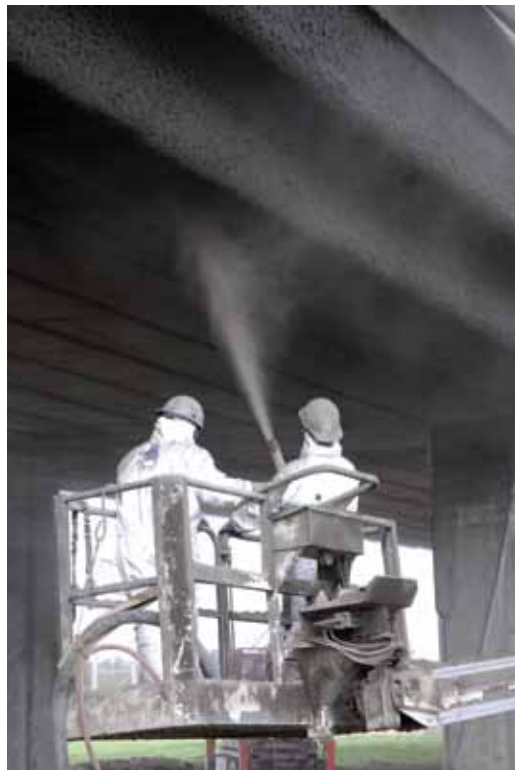
Fig. 7: A repair zone is blasted to clean the reinforcing bar and the substrate

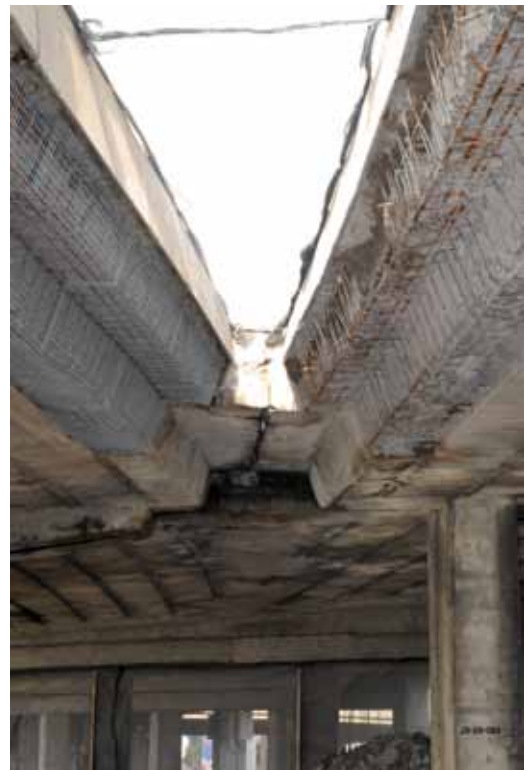
Fig. 8: Welded-wire steel mesh conforms to the stepped trapezoidal cross section

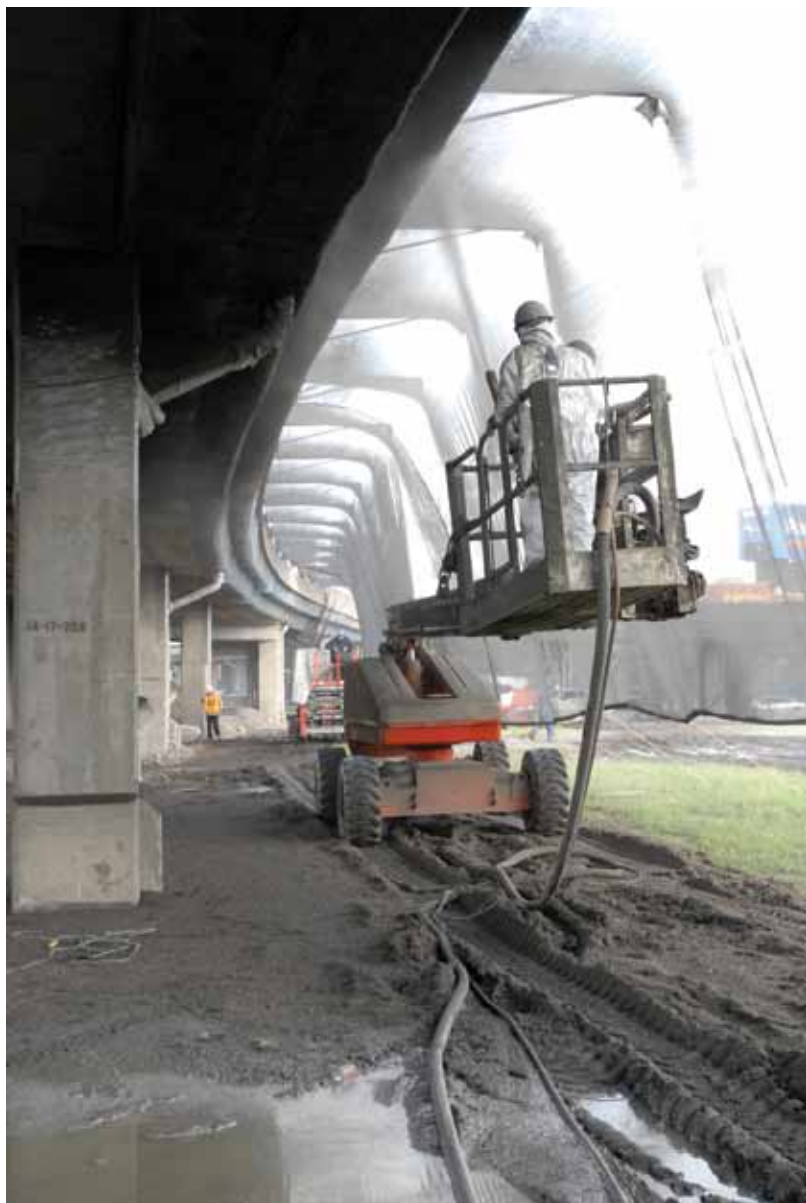
Fig. 9: Applying shotcrete from a distance of 2 to 6 ft (0.6 to 1.8 m)

King Packaged Materials Company’s MS-D1 Shotcrete was then carefully applied according to ACI 506R-05, while also accounting for variable environmental factors such as wind and rain. The mixture design met all MTQ requirements, including the specified air void spacing factor of less than or equal to 300 μm , with no singular value exceeding 320 μm , as tested with ASTM C457. The air entrainment of the dry-mix shotcrete was critical on this project to provide superior freezing-and-thawing durability and also a high resistance to scaling caused by deicing salts—two major causes of concrete deterioration in a northern climate. A manlift was used to maintain the optimum distance and position between the nozzle and the repair—that is, between 2 and 6 ft (0.6 and 1.8 m)—and roughly perpendicular. The shotcrete was applied in the optimal number of layers to not exceed the plastic shear resistance

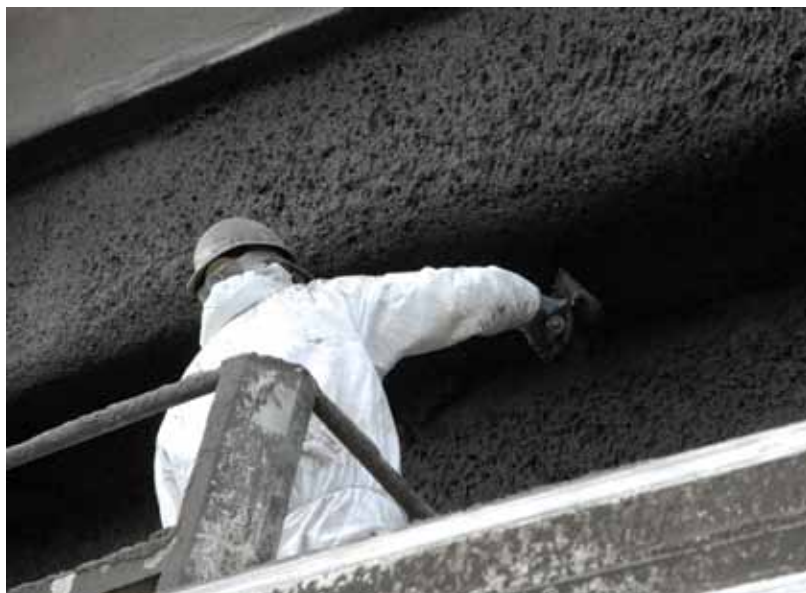
Fig. 10: The rough finish was achieved with a steel trowel

of the material, thus avoiding fallouts or repair deboning. Good reinforcing bar encapsulation was also carefully executed. The rough finish of the shotcrete repair was done with a steel trowel and the final finish was achieved with a wood float. Finally, a liquid curing agent conforming to ASTM C309 was applied immediately after finishing to ensure adequate curing, as specified by Transports Québec for overhead repairs.
